6.0 The Site

At the outset of any planning project, it is helpful to prepare a study area boundary even though it is imperative to consider the greater context; in this case the Black Rock Riverside community as well as the Buffalo Niagara region. There are two boundaries that define the Black Rock Canal Park project.

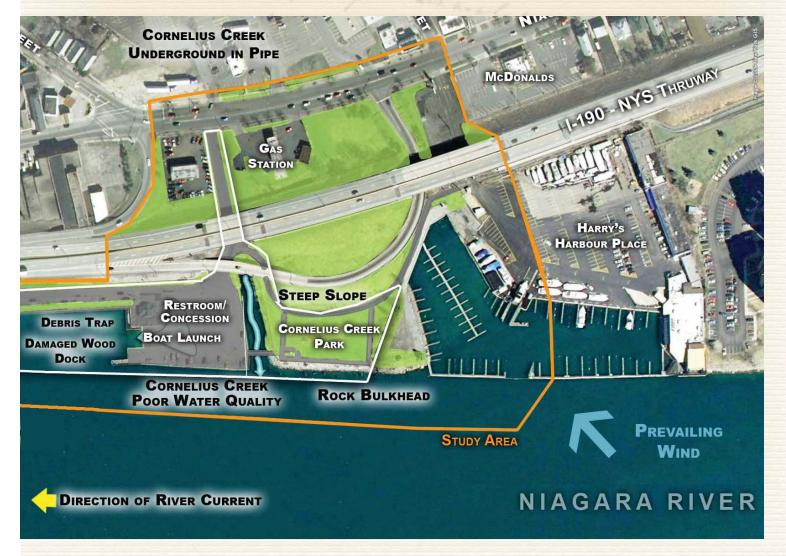
This portion of the site consists of a large parking lot that is paved to all edges with only two small planters to break up the expanse. The west edge of the parking along the Niagara River has a sheet pile bulkhead topped by a railing that is broken is several areas. It is frequently used by anglers who like to be near their vehicles and by people in vehicles just enjoying the view of the Niagara. The boat launch ramp and parking area were renovated in 1990. The actual sloped boat launch ramp is in reasonable shape despite its age.

There is a small wood dock where the bulkhead turns east toward the boat launch that should be replaced since it is warped and does not connect with the adjacent grade.

A quick visual inspection of the parking area shows that the paving seems to be stable and solid except immediately behind the bulkhead where it regularly sinks and is an on-going maintenance concern.

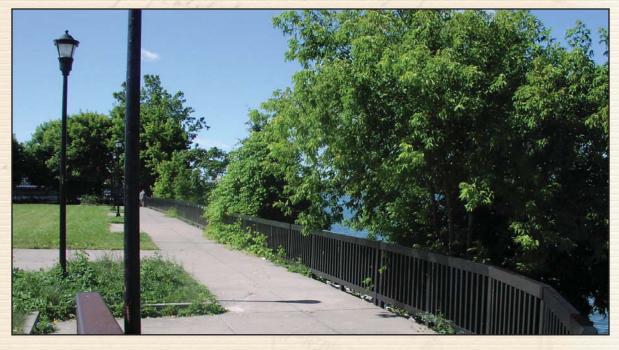
Looking across the pedestrian bridge from the boat launch parking area into Cornelius Creek Park

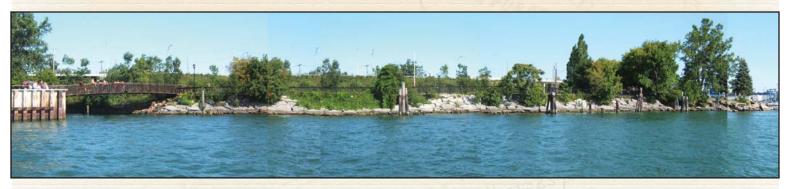
A view of the mouth of Cornelius Creek, the pedestrian bridge and Cornelius Creek Park from the Niagara River. The south end of the boat launch parking area is visible at the left side of the picture.

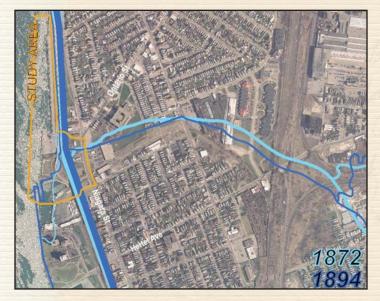
The above graphic illustrates the historical alignment of the Niagara River shoreline, the Eric Canal (running north-south parallel to the Niagara River) and Cornelius Creek (running east-west) superimposed on a current aerial photograph. The Eric Canal followed the route of the I-190. Cornelius Creek emptied into the Eric Canal. The park generally occupies land that was created from fill since 1894.

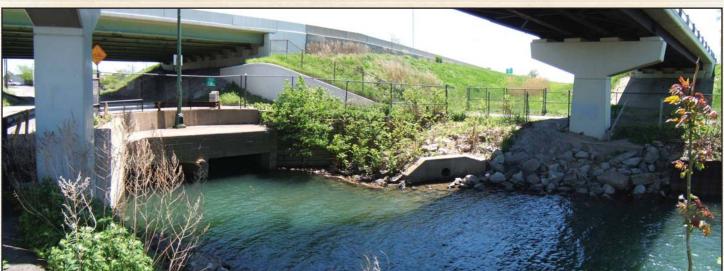
Cornelius Creek emerges from below ground via a box culvert under the park entrance road, below.

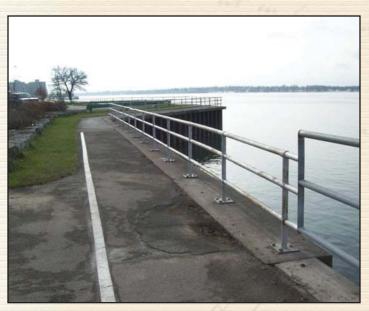
View of wall from parking lot looking north.

The wall consists of a Z-style 3/8 inch thick interlocked steel sheet pile cantilevered retaining wall measuring approximately 2,200 feet long. The sheet piles are generally capped using a steel channel and a concrete overlay. There is one section of wall near the boat launch that has some deflection but this appears to be an as-constructed condition and not the result of damage.

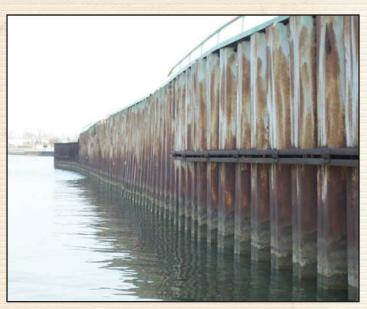
View of north creek wall and pedestrian bridge over mouth of Cornelius Creek.

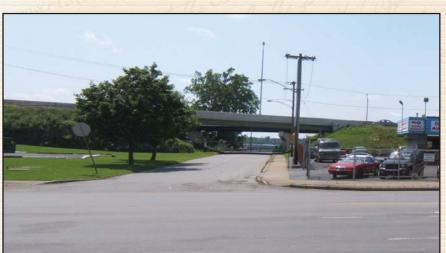
The understated and poorly marked park entrance road leads west from a three-way intersection on Niagara Street.

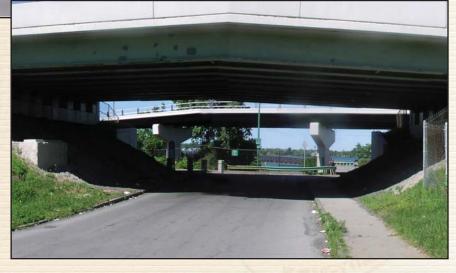
Traveling west along the entrance road takes the park user under a series of I-190 overpasses. The entrance road bends to the right towards the parking area, while the view continues down Cornelius Creek.

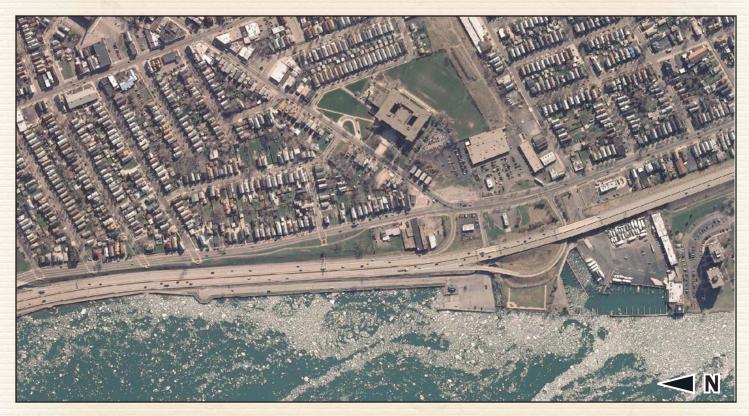
This aerial photo illustrates how ice, or other floating debris, that travels down the Niagara River is blown by the prevailing wind against the eastern shore of the river.

The prevailing wind direction is from the southwest. This is readily apparent to the casual observer who need only look at the condition of the existing trees that lean in a northeasterly direction. The prevailing wind direction combines with the direction of water flow (described below) pushing floating debris toward the boat launch. Wind can be extremely strong in this area due to the expanse of open water down-wind.
